# Fiber Orientation in Fiber-Reinforced Plastics and How it Affects Automotive Applications

E. M. Rowbotham  
Ford Motor Co., Ltd.

Automotive Engineering Congress  
Detroit, Mich.  
February 25 - March 1, 1974

740264

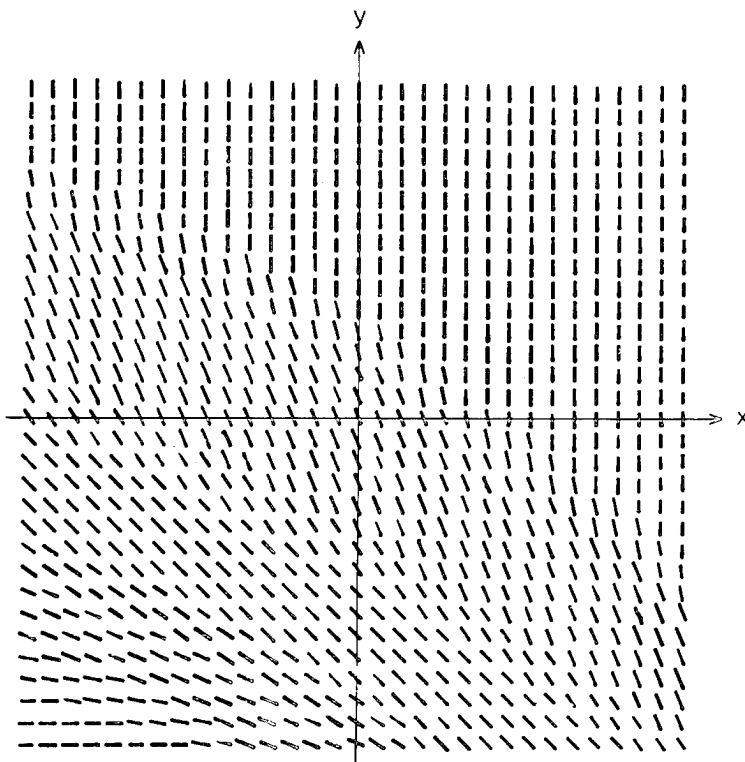
Fig. 2 - Schematic representation of preferred fiber orientation deduced from analysis of strength

From microscopic examination of the fracture surface, we were able to obtain a measure of the angle the fibers made with the specimens axis and consequently with the X-axis. By correlating the angle of the fiber with the strength measured and the position of the specimen in the plaque, we were able to map (Fig. 2) the fiber pattern within the plaque and also estimate the extent to which fiber orientation was contributing to the resulting scatter—75% could be attributed to fiber orientation.

Fig. 2 shows the fiber pattern predicted from the test results. This particular pattern is unusual, in that it portrays a fiber pattern normally associated with a quarter section of a square plaque. However, the fiber pattern will only repeat itself if all the factors involved in the molding are reproduced. For instance, the fiber pattern can alter due to the positioning of the molding charge in the mold cavity or even to the cocking of the upper press platen during mold closure. Anything that produces different flow characteristics of the molding charge can create variations in the fiber orientation obtained.

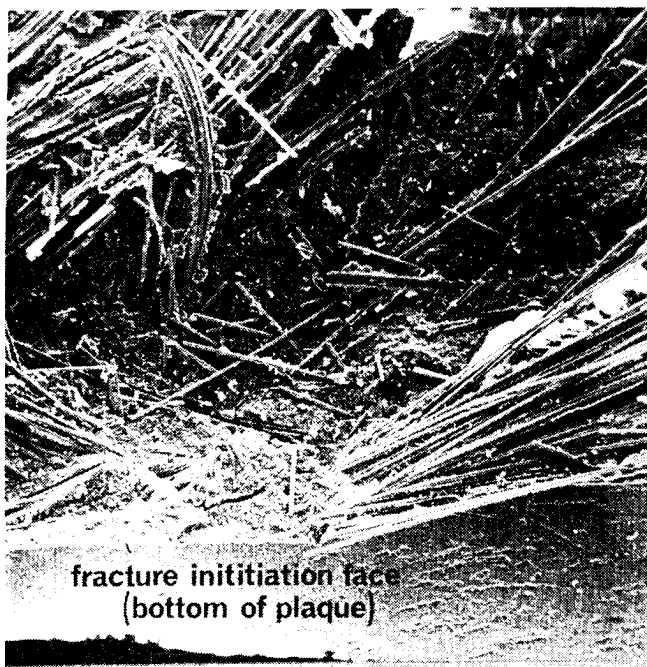
Fig. 3 - Fracture surface of low-strength specimen, stereoscan micrograph, X40 reduced 55% for reproduction

Fig. 3 is a stereoscan micrograph of the fracture surface of a low-strength specimen. It will be observed that fiber orientation lies predominantly perpendicular to the specimen's axis. A stereoscan micrograph of a high-strength specimen's fracture surface (Fig. 4) showed the fibers oriented parallel to the specimen's axis, while in Fig. 5, a medium-strength specimen depicts the fibers angularly disposed between the longitudinal and transverse axis of the specimen. Fibers so aligned will only partially contribute to the overall strength of the test piece.

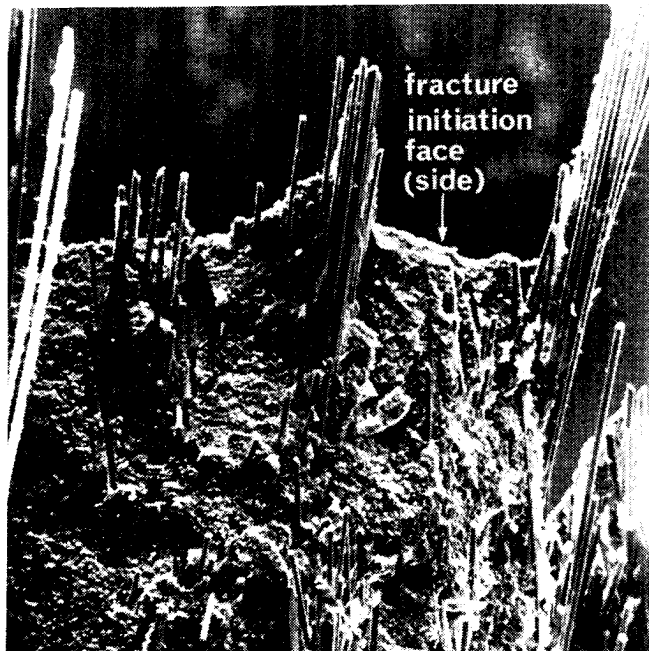
Fig. 4 - Fracture surface of high-strength specimen, stereoscan micrograph, X85 reduced 55% for reproduction

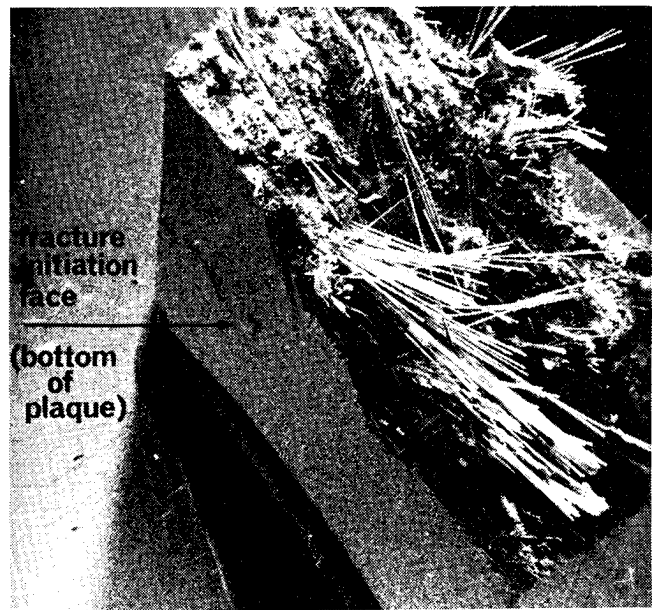
Fig. 5 - Fracture surface of medium-strength specimen, stereoscan micrograph, X15 reduced 55% for reproduction

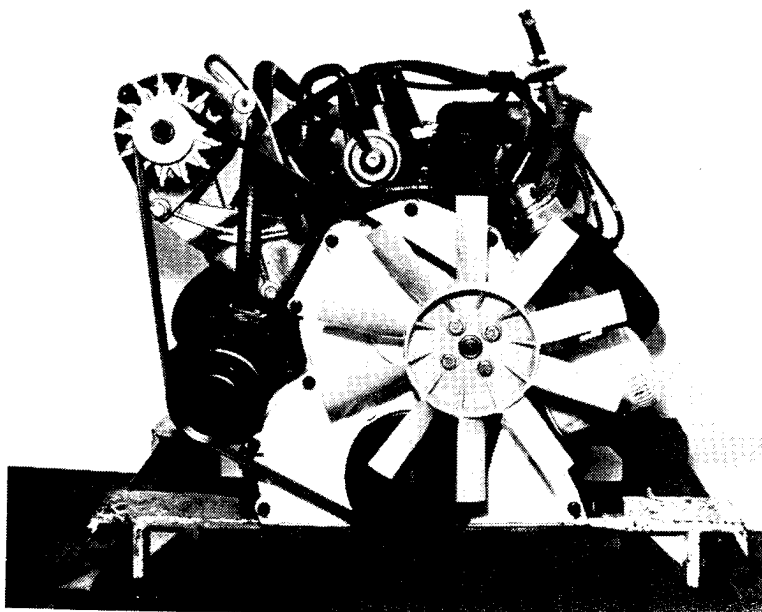
Fig. 6 - Front timing cover assembled to engine

was made from 20% glass DMC (6 mm fiber length). The design was basically the same as its aluminum counterpart with only minor modifications such as slight thickening of the molding's outer periphery, inclusion of an extra reinforcing web at the root of the radiator fan boss, and omission of the circlip access aperture, normally included when mechanically fixing the radiator fan bearing. It is a functional component supporting the fuel pump, radiator fan, and bearing. The oil sump is bolted to the molded inserts located in bosses on the bottom sealing flange. Operationally, the component is subject to both static and dynamic stress. The fatigue stress is illustrated in Fig. 7. All tests were carried out on a 500 h engine hot test (Appendix A), inspection being made every 50 h. Tests were terminated depending upon where and to what extent cracking had occurred. Sections of the molding were cut and etched (Appendix B) to reveal the fiber orientation associated with the failure.

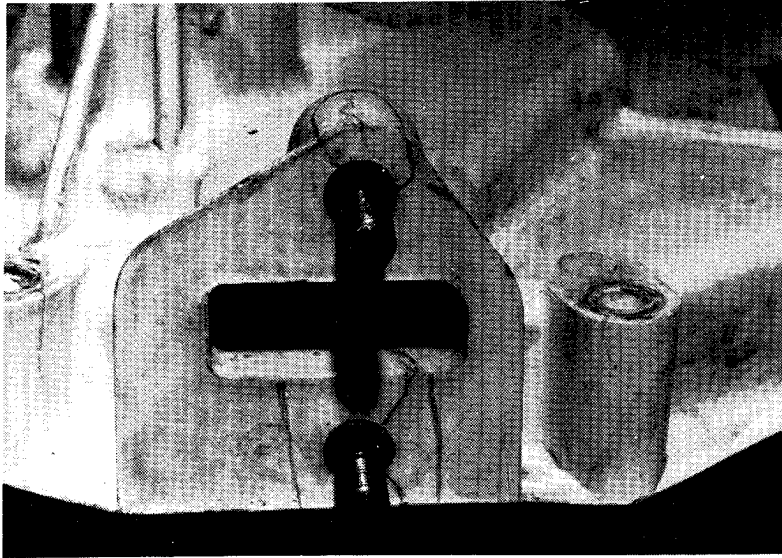
**FUEL PUMP FLANGE** - This flange was particularly vulnerable to cracking (Fig. 8). The geometry of this molding section with its retractable core and inserts created a characteristic flow in the material during molding. Etched sections (Fig. 9) showed how the material flow separated into two streams on either side of the retractable core, joining together again on either side of each of the two inserts to form a characteristic weld line. The glass fiber followed the flow, orienting itself parallel to the weld line. The glass fiber never bridged the weld line. Cracking occurred either at the resin weld line or parallel to it, following the fiber orientation on either side of the insert. Of the 36 moldings tested, only one did not fail in this manner.

Fig. 8 - Front timing cover fuel flange showing typical cracking

Redesign and change in the molding technique is currently being undertaken to obviate failure; for example, placing molding material, SMC or DMC, into this section of the mold cavity prior to molding, thus reducing the flow of the material; or, delaying the placement of the core and the inserts until the mold is full but while the material is still in an uncured condition.

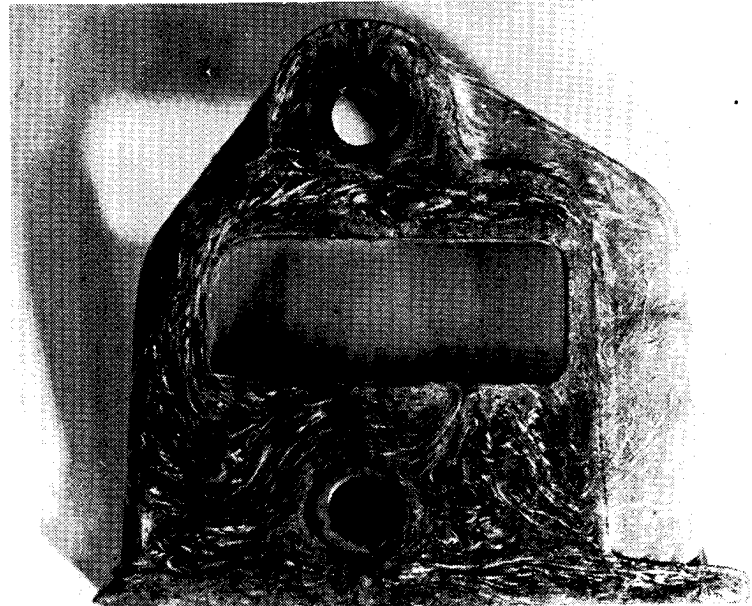
Fig. 9 - Front timing cover fuel flange etched to show fiber orientation

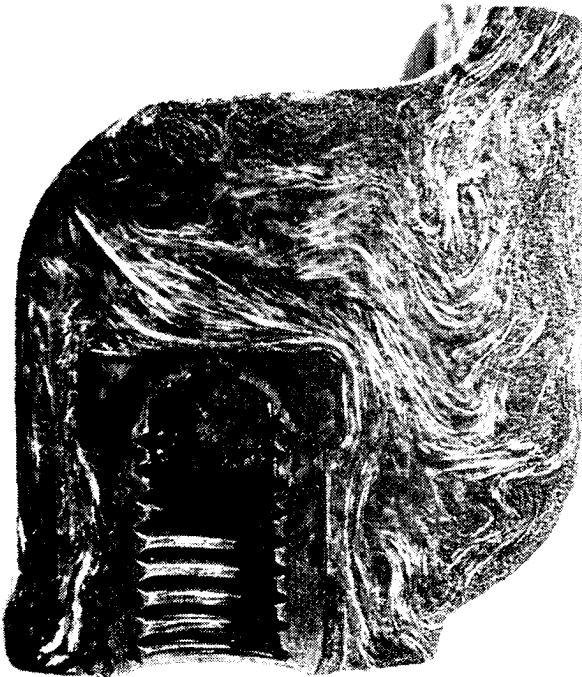
**OIL SUMP BOSSES** - Cracking of the oil sump bosses (Fig. 10) was generally present but not always in an identical position. Etched sections of the bosses (Fig. 11) showed a weld line across the top of the boss and fiber orientation parallel with the axis of the insert around the boss periphery. Cracking followed any line along the fiber orientation. No problem was experienced with the weld lines occurring on the top of the bosses because no adverse stress appeared to be present. The fiber orientation was obviously occurring due to the flow of the material around the insert. The close proximity of the insert to the molding tool wall caused the material, during flow, to be subjected to shear forces from the tool surface as well as from the inserts' surface. A combination of both of these shear forces did not allow any random fiber orientation in this comparatively thin section of molding. Delaying the placement of the insert until material flowed into the boss area and then forcing the insert into the still-uncured material could resolve this problem.

Fig. 11 - Front timing cover oil sump support boss section etched to show fiber orientation

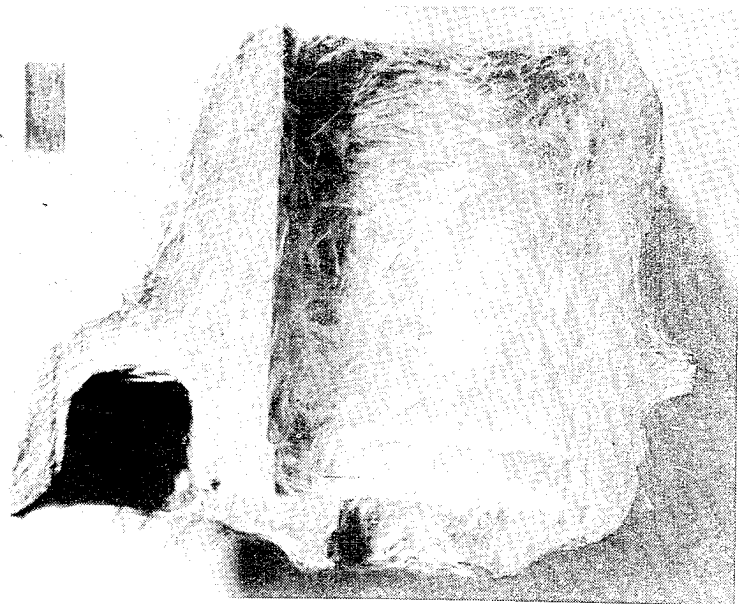
**RADIATOR FAN-BEARING HOUSING** - Cracking occurred in the fan-bearing housing either when pressing in the bearing or during engine test. When cracking occurred, fiber orientation was always aligned axially to the bearing (Fig. 12), which was adverse to the hoop stress operating on the fan-bearing housing.

Fig. 12 - Front timing cover fan bearing housing section etched to show fiber orientation

Random fiber orientation could be achieved by lining this section of the mold cavity with SMC material. The SMC, being randomly oriented and not required to flow any distance during molding, did not produce fiber alignment.

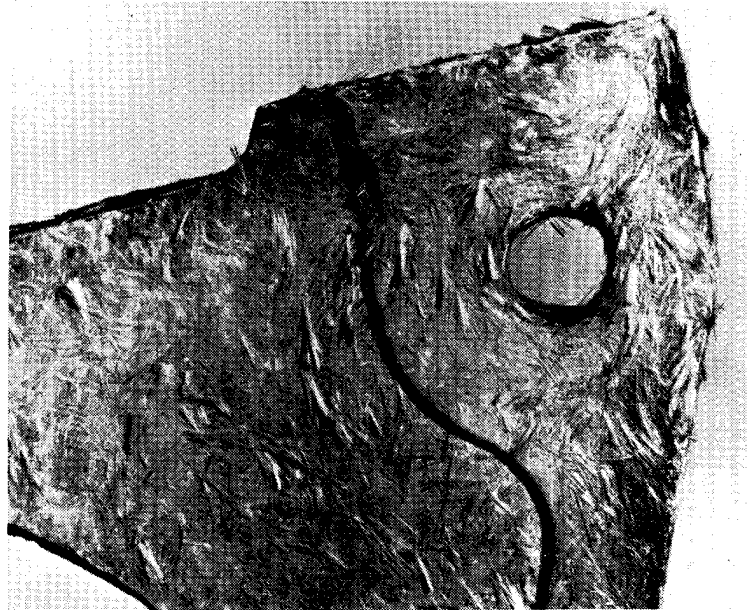
Fig. 14 - Crankshaft rear seal housing showing fiber orientation around molded-in fixing holes

although the design, at first sight could be equally good for plastic. Low-shrink DMC (15% glass, 6 mm fiber) was chosen for this component because of the need to maintain close tolerances and flatness. The DMC moldings were first tested on engine rig tests followed by vehicle trials. No functional failures were experienced with any of the moldings tested, although cracking occurred at the bolt holes and on the bosses. Etched sections, using the technique described in Appendix B, were prepared. Again, fiber orientation associated with weld lines was present around the four fixing bolt holes (Fig. 14). Cracking followed either the resin-rich area of the weld line or the fiber orientation running parallel with it.

The molding was molded without bolt holes present, the holes being jig-bored later as a secondary operation. While this obviated the orientation problem, it also invoked a cost penalty. Closer inspection showed that this problem could be rati-

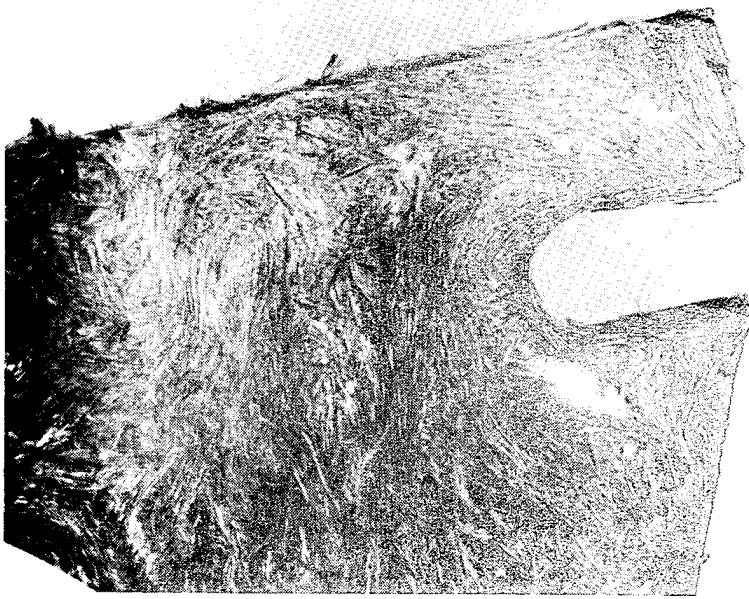
Fig. 15 - Crankshaft rear seal housing showing fiber orientation around molded-in fixing slot

fied by molding in slots instead of holes (Fig. 15). No adverse orientation was experienced with this technique, while the gasket seal face was still maintained, all at no additional component cost.

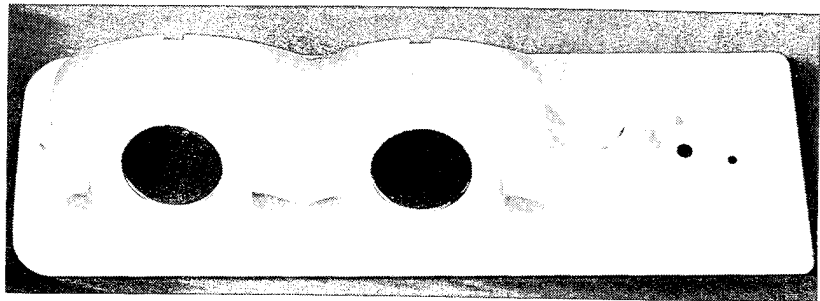
Fig. 16 - Rear tail lamp housing

Fig. 16 shows a molding of a rear lamp housing that has been injection-molded from 20% glass DMC, 6 mm fiber length. As can be seen in this molding, the sections are extremely thin; so the shear effects on the material during flow should be very high, thus producing gross fiber orientation. The etched surface of this molding (Fig. 17) shows almost complete random surface fiber orientation, apart from the slight swirl condition present around the feed sprue area. A section of this same molding with the surface skin ground off to reveal the material core shows the fiber orientation that was anticipated to occur on the surface (Fig. 18). The exact reason for this effect has not been elucidated. However, the internal forces in the flowing material must be greater than the frictional forces being experienced at the mold surface and must, therefore, become the controlling factor. Whether this is a function of the particular mold surface or the fact that the material, when injection-molded, is very close to its curing temperature and, thus, has a higher viscosity than compression-molded material, or that the material is being forced very rapidly through the mold, has not been established, but we suspect it is a combination of all these factors.

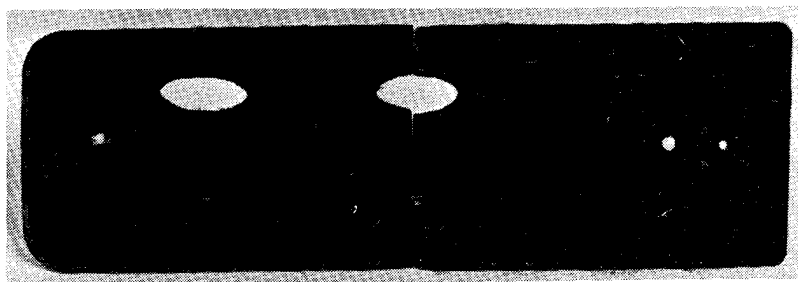
Fig. 17 - Rear tail lamp housing etched to show surface fiber orientation

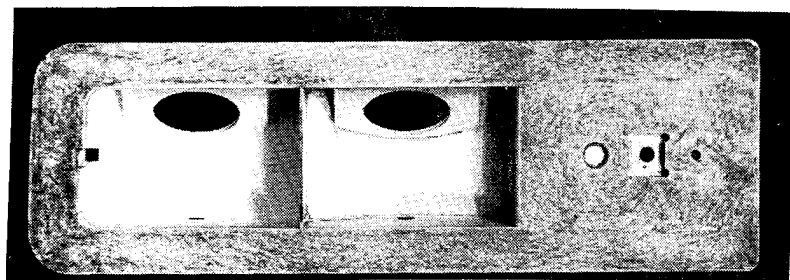
Fig. 18 - Rear tail lamp housing section showing fiber orientation in core

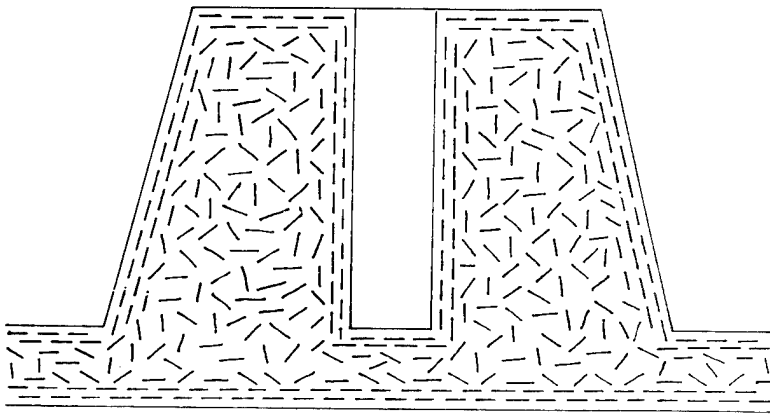
molded components, because of the high risk of stud misplacement during molding and the consequent very costly damage that can occur to the molding tool. The tendency is to mold-in holes and use either self-tapping screws or bolts that are capable of cutting their own thread. Pull-out loads and stripping torques for the screws/bolts can be very high and provide a very good method of assembly. However, the relationship between the hole diameter and the molded skin on the inside of the molded hole, which tends to contain adverse fiber orientation, is very important. Fibers tend to align themselves parallel to the molding pin axis, and, if the pitch of the self-tapping screw or bolt is insufficient to penetrate the skin and locate the thread in the randomly oriented core material, then the pull-out load and the stripping torque will be very low indeed. The decrease is generally of a factor of four magnitude. For maximum retaining strength, fiber must lay transversely with respect to the screws/bolts axis in the areas of thread engagement (Fig. 19).

Fig. 19 - Section through boss with molded-in hole indicating fiber alignment
